CANDELARIA

CHILI

Réussite de l'utilisation en PP pour un dépôt de classe mondiale !

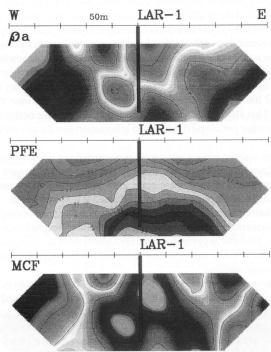
A dipole-dipole IP survey ($a=50$ m, $n=1$ to 6) was conducted to evaluate the sulphide potential closest to the known deposits and in the surrounding area.

Interpretation and modeling indicated the presence of mineralization at depth on line 700N. This was confirmed by percussion drilling and later by diamond drilling that encountered 22m averaging 2.5% Cu with significant gold.
